THE APPLICATION OF DRONE TECHNOLOGY TO MONITOR AND ASSESS COASTAL ENVIRONMENTS AND PROJECTS

North Carolina Beach and Inlet Waterway Association
Wilmington, NC

COASTAL
PROTECTION
ENGINEERING

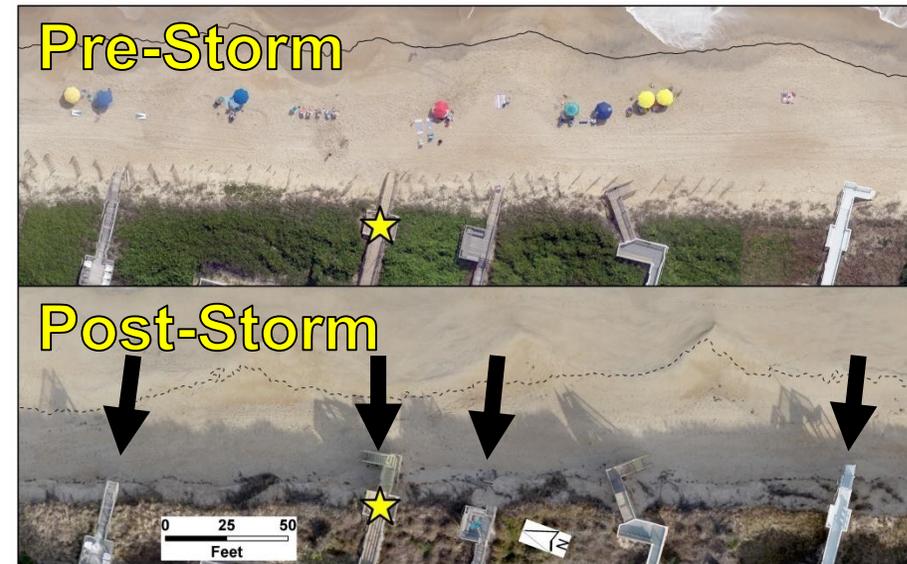
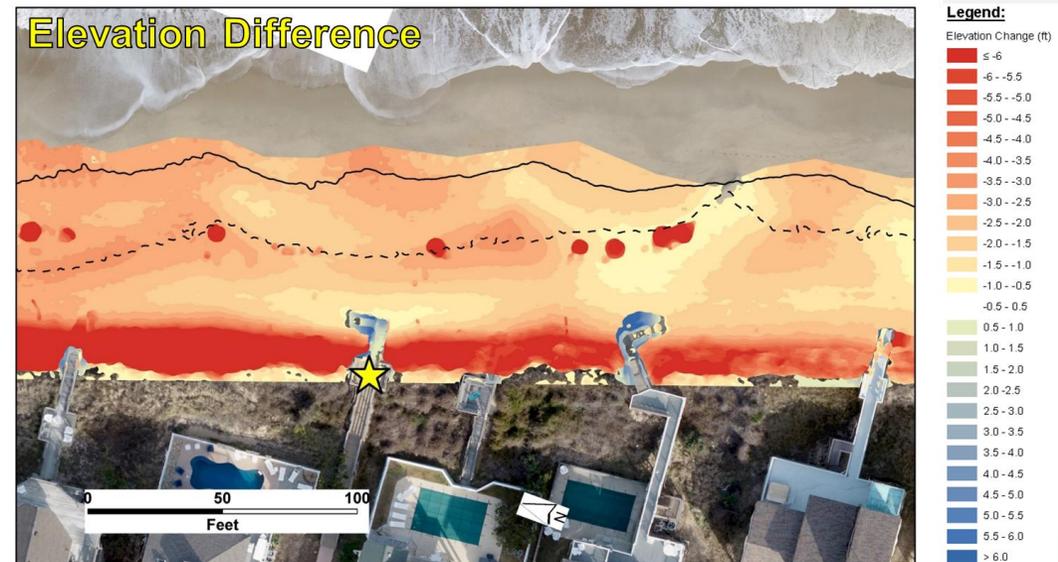
RAPID BEACH ASSESSMENT – DUCK & PINE ISLAND, NC

- Pre- vs Post-Storm
- Pre- vs Post-Nourishment
- Track Contours
- Identify Storm Impacts
- Volumetric Analysis
- Elevation Difference Plots
- Quick Analysis (2D & 3D)

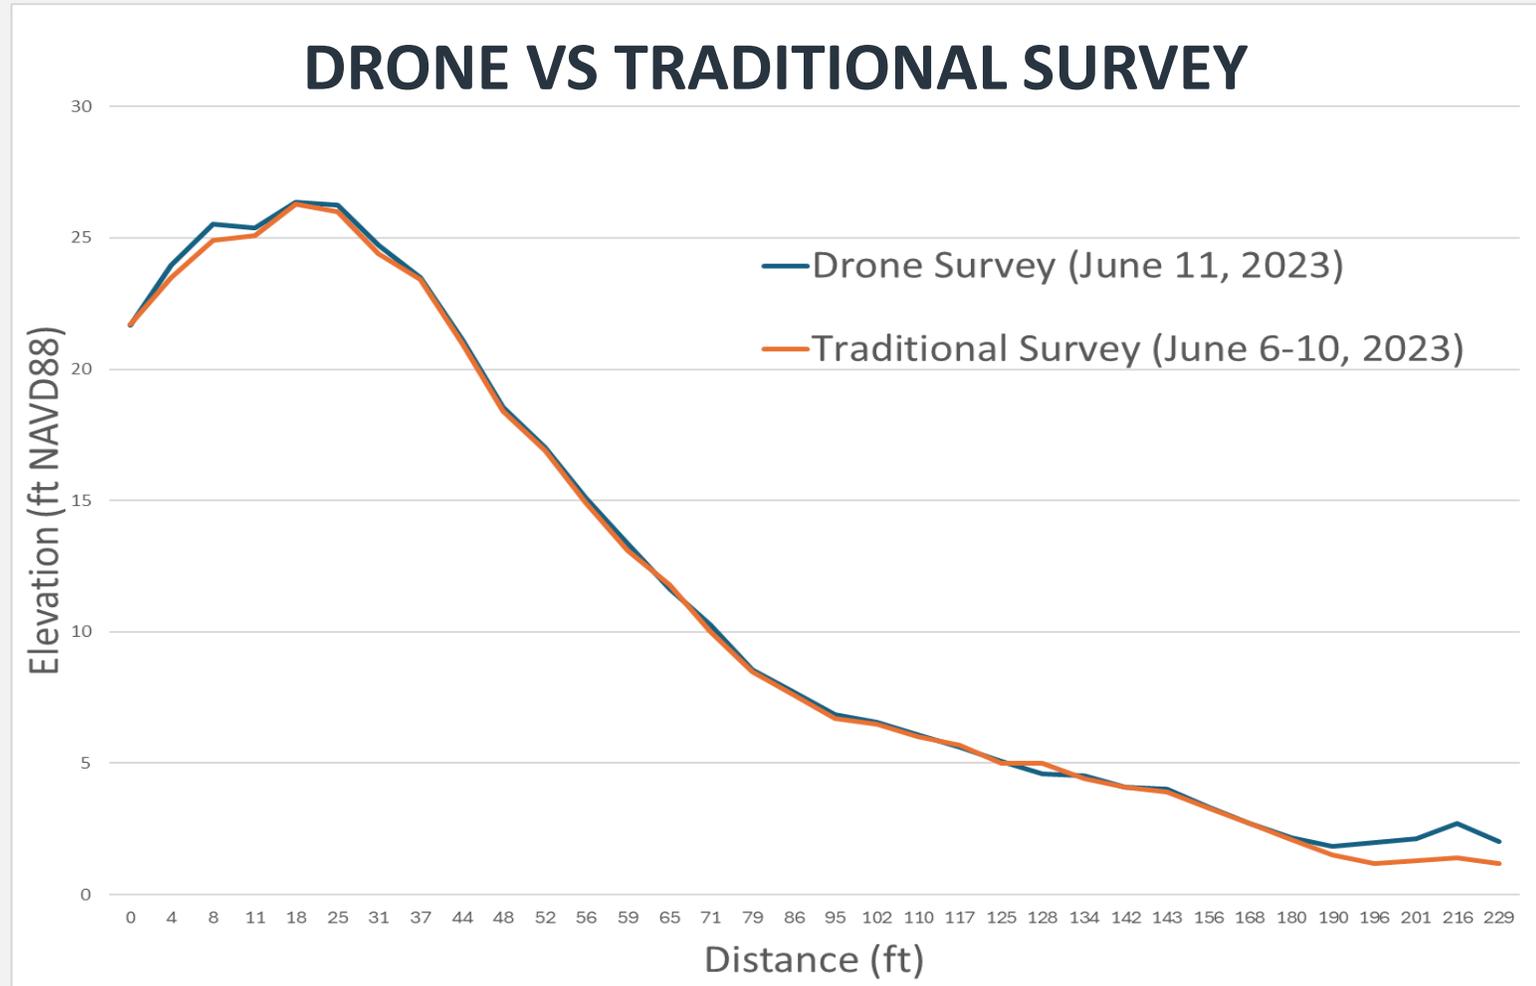
RAPID BEACH ASSESSMENT – DUCK & PINE ISLAND, NC

- Accurate data collection for bare-earth areas
- Minimal personnel & equipment needed
- Data Collection Decreased Time & Increased Coverage
- Challenges Vegetation, Water, Shadows

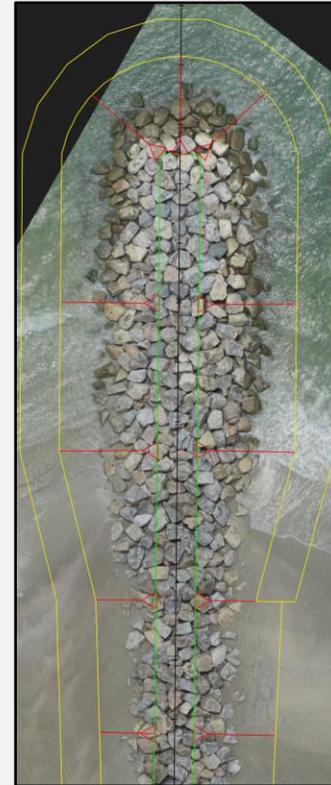
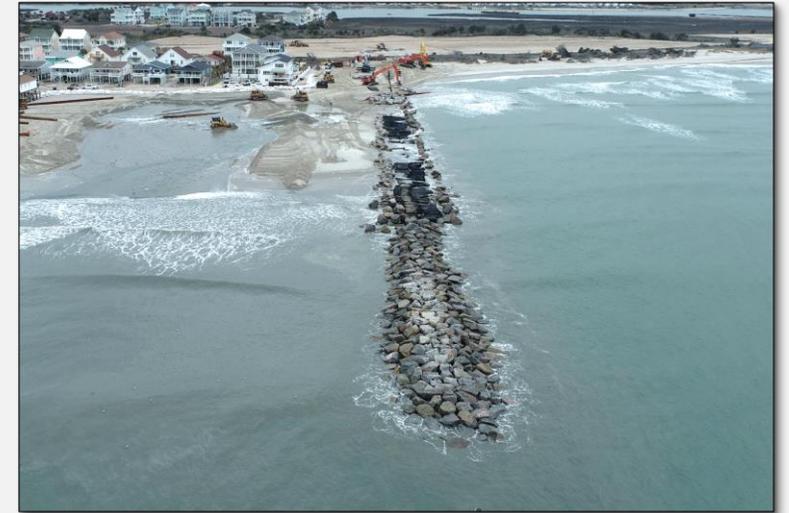
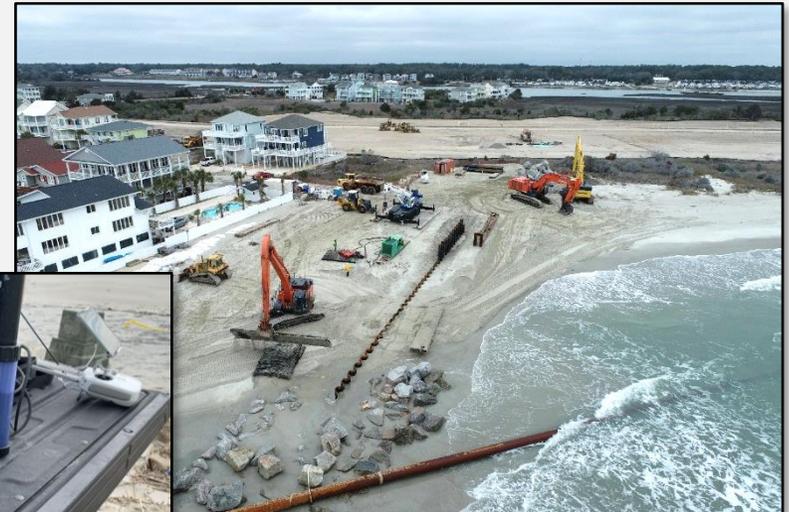
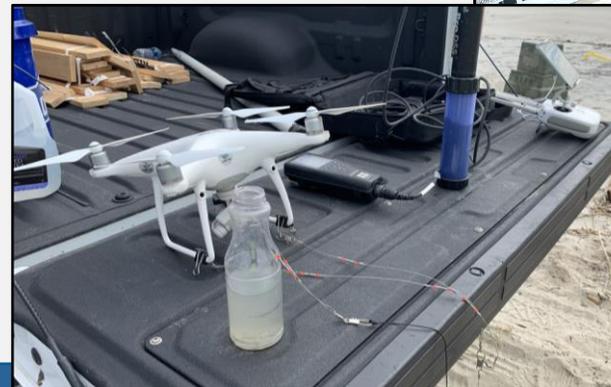
CONSTRUCTION OBSERVATION - OCEAN ISLE BEACH TERMINAL GROIN

- Provides “Birds-eye” View
- Quick Deployment
- Overlay Construction Thresholds on Imagery
- Hi-res Orthomosaic Imagery for Tracking Progress
- Identify Inspection Areas
- Physical Sampling

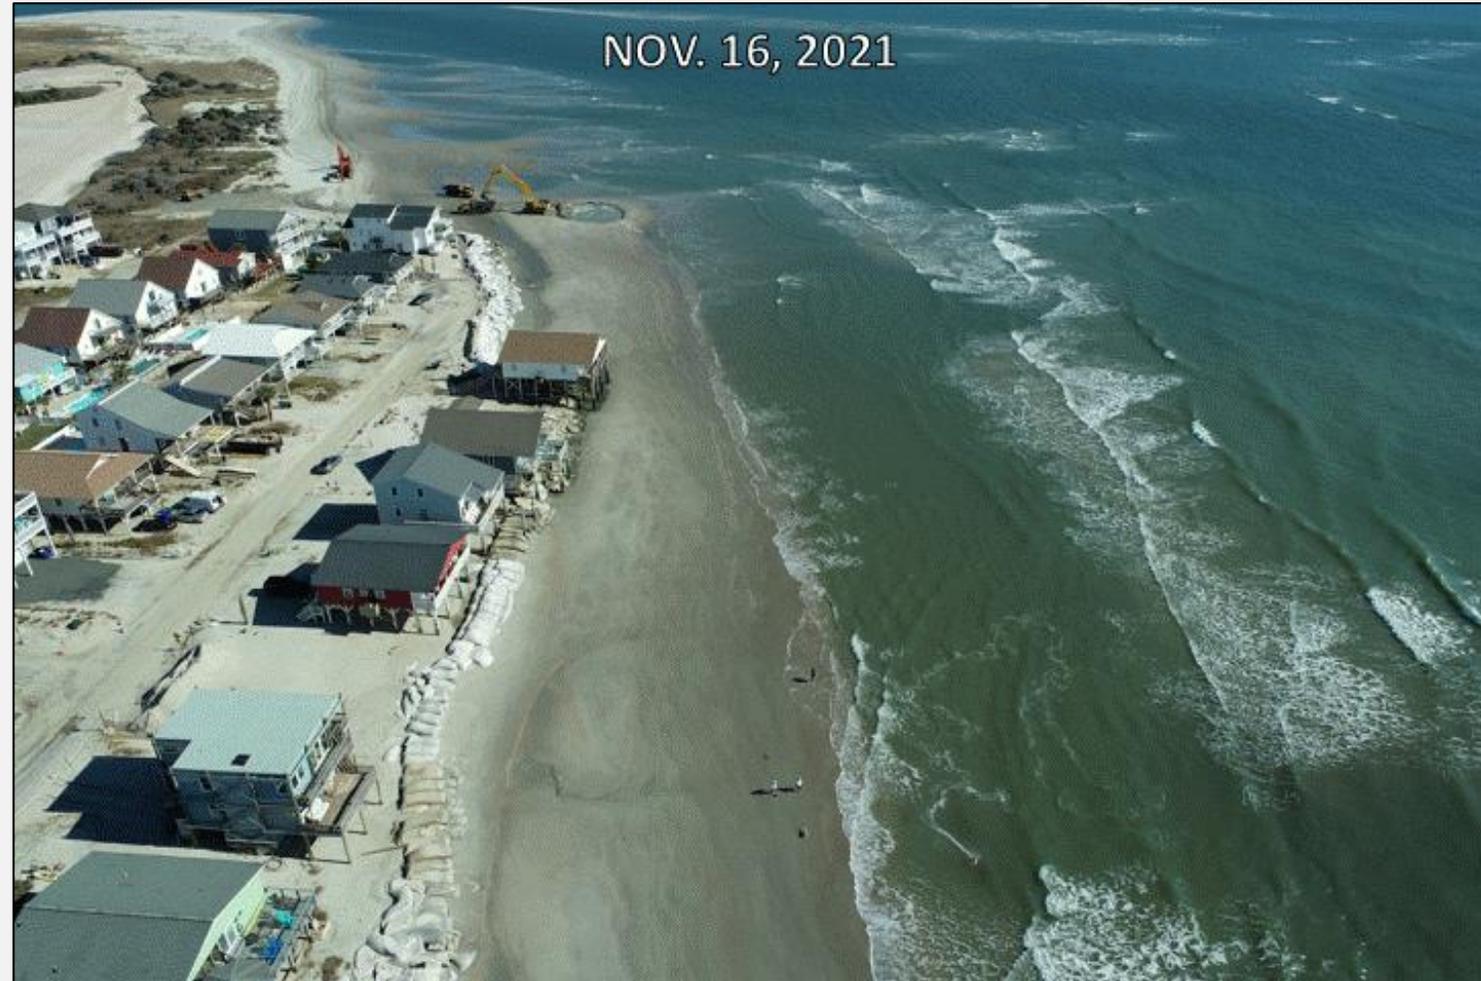
CONSTRUCTION OBSERVATION - OCEAN ISLE BEACH TERMINAL GROIN

- Time-lapse of Construction Daily Progress
- “Way-point” Flight Plan
- Collect Photos/Videos Same Location

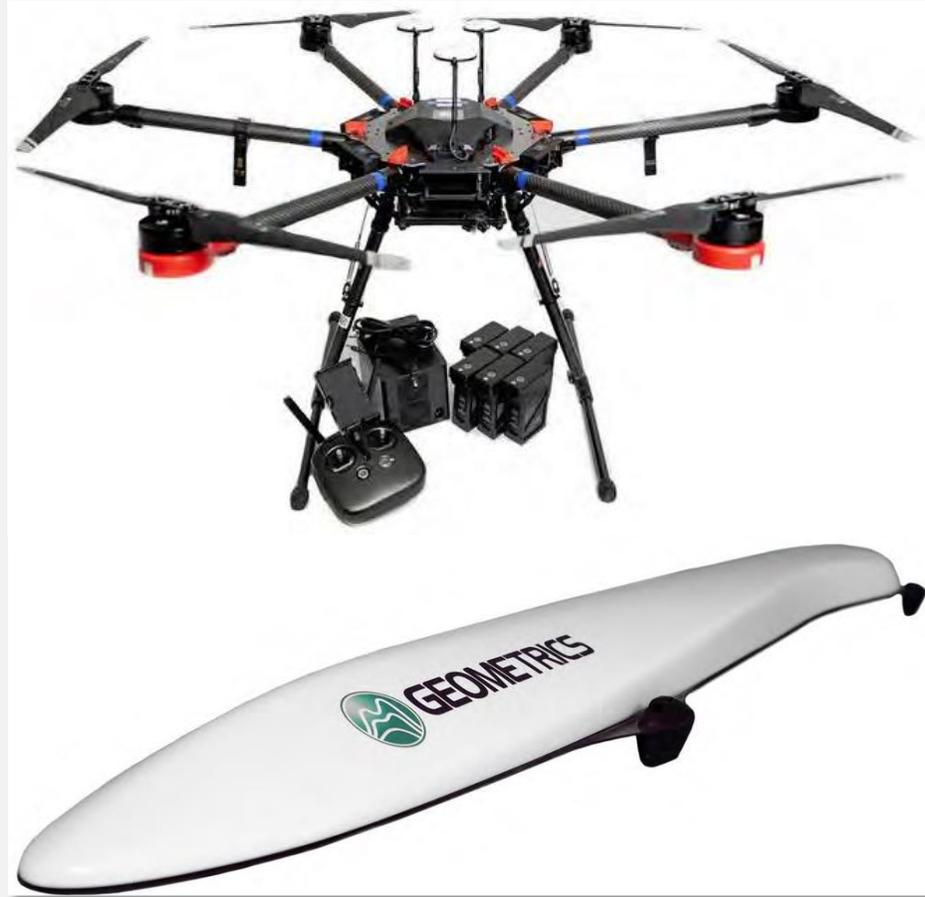
**DJI Matrice 600 hexacopter
Geomtetrics MagArrow UAV magnetometer**

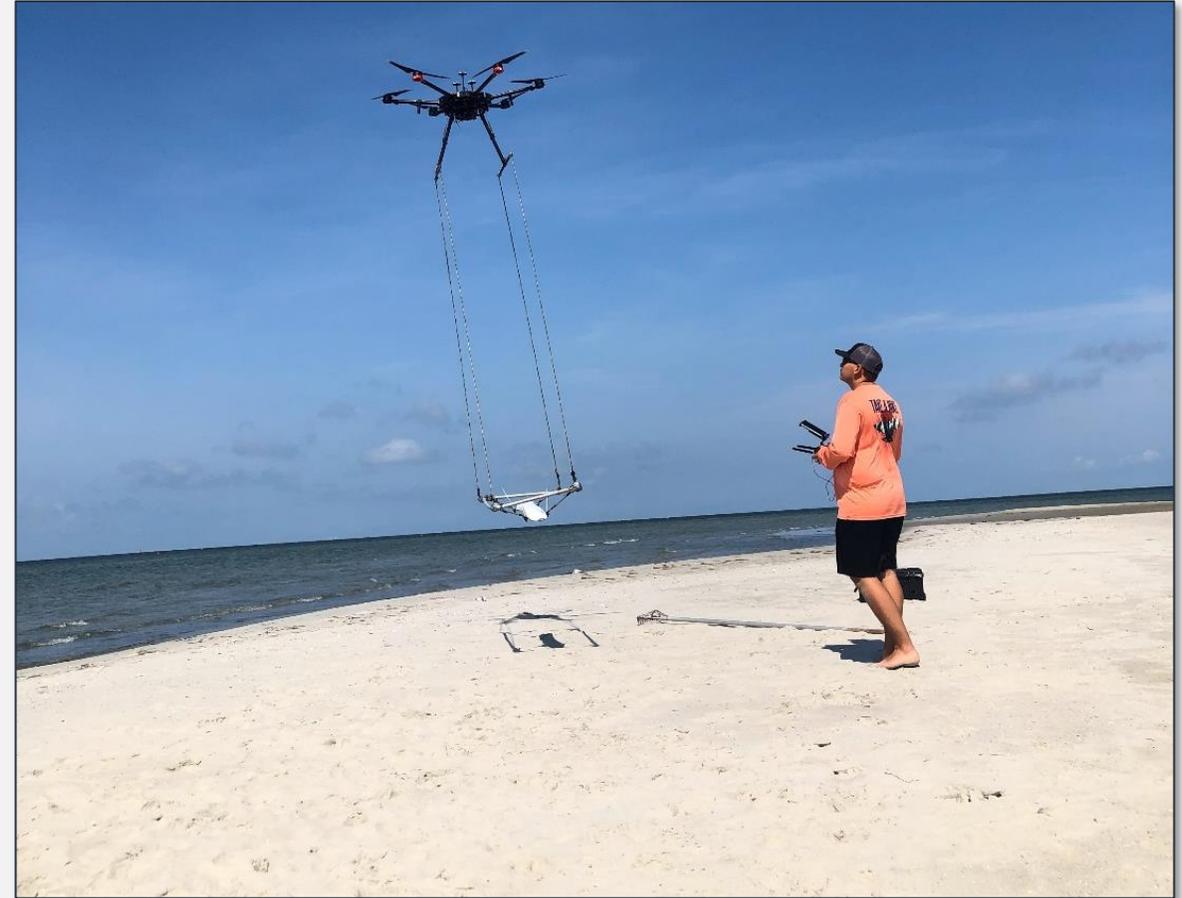
CPE Pilot launching from shoal within Hatteras Inlet

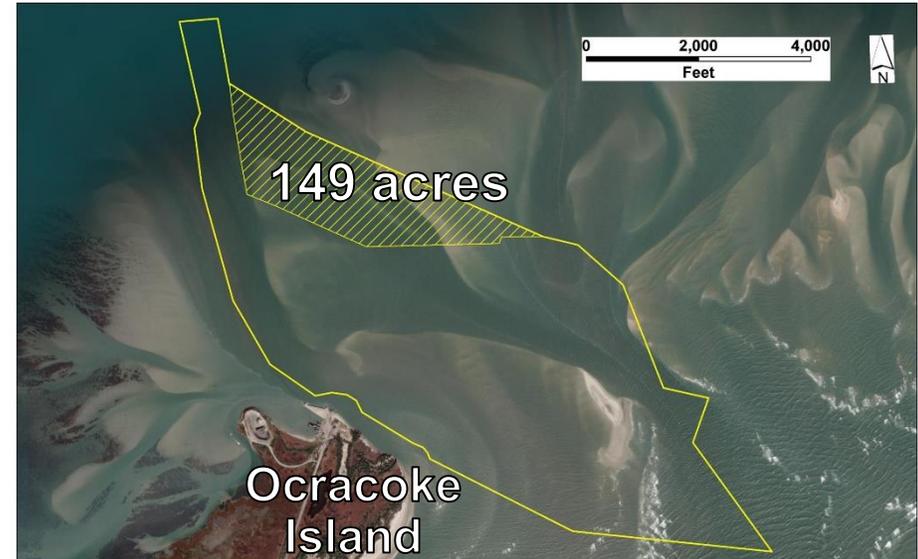
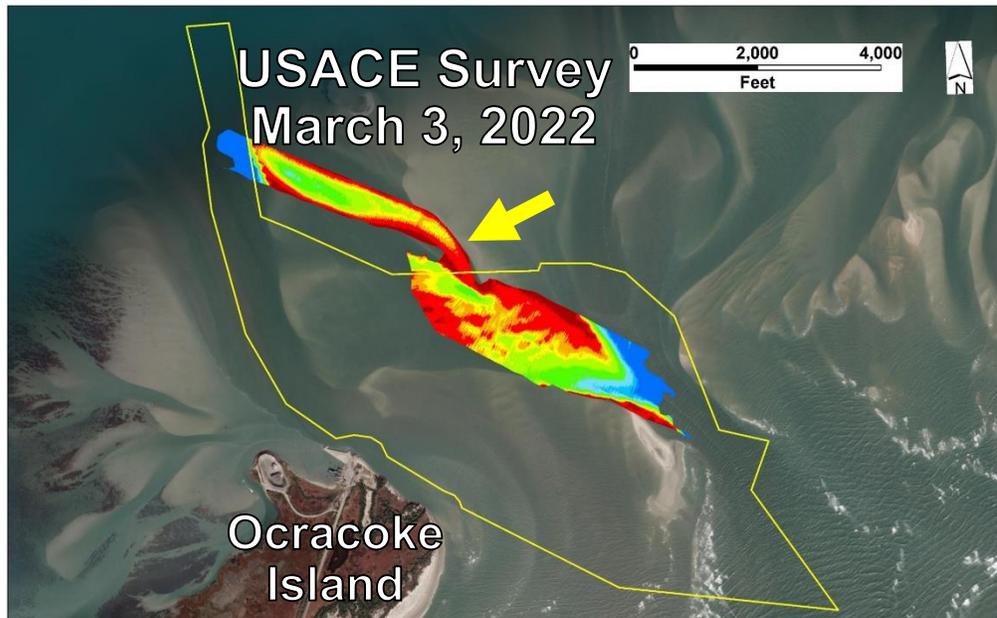
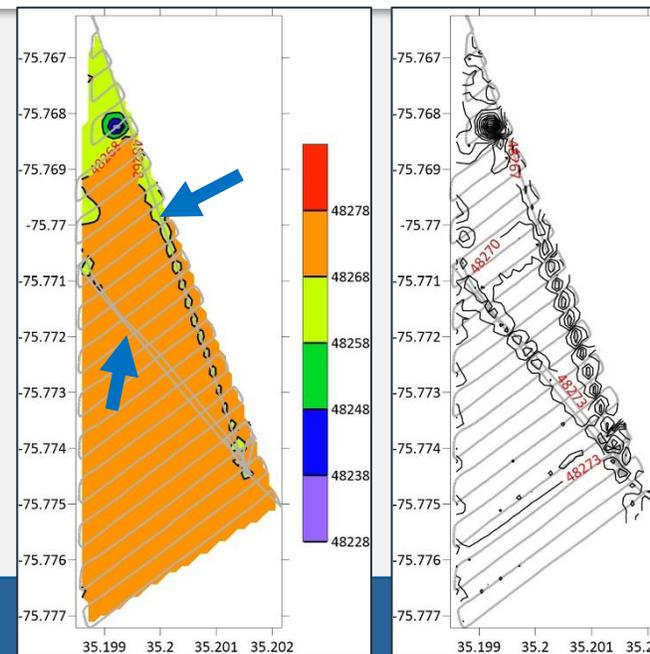
CULTURAL RESOURCE SURVEY – UAS MAGNETOMETER SURVEY

Blue Arrows
Identify Existing
Submerged
Electrical Cable

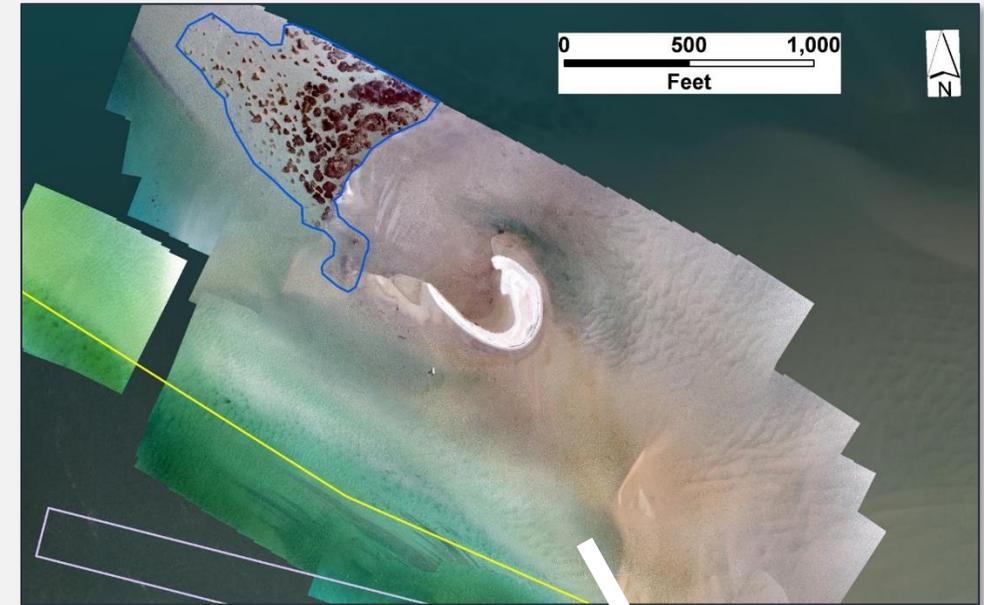
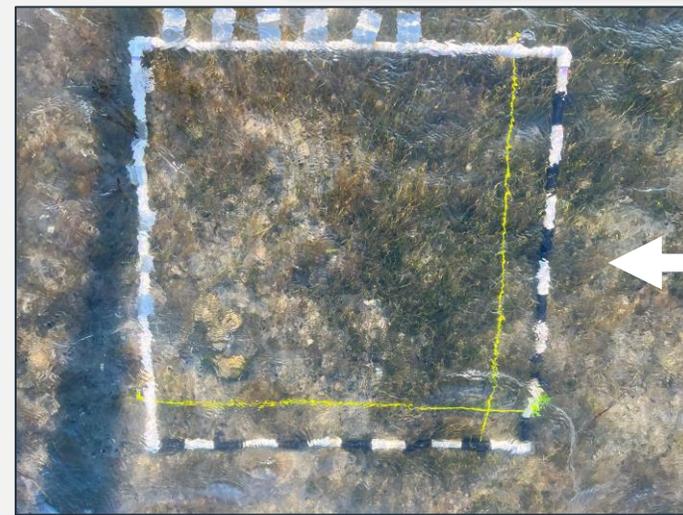
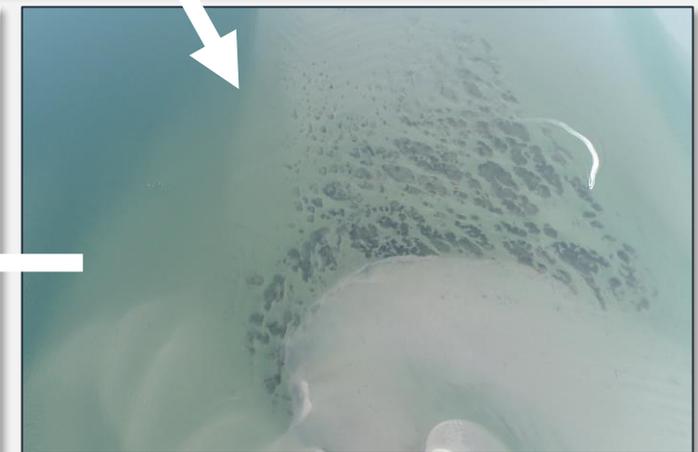
SUB-AQUATIC VEGETATION (SAV) SURVEY - HATTERAS INLET

- Assess Navigation Channels ahead of Maintenance Dredging
- SAV Habitat Delineation
- Hi-Res Over-water Images
- Aid in Ground Truthing

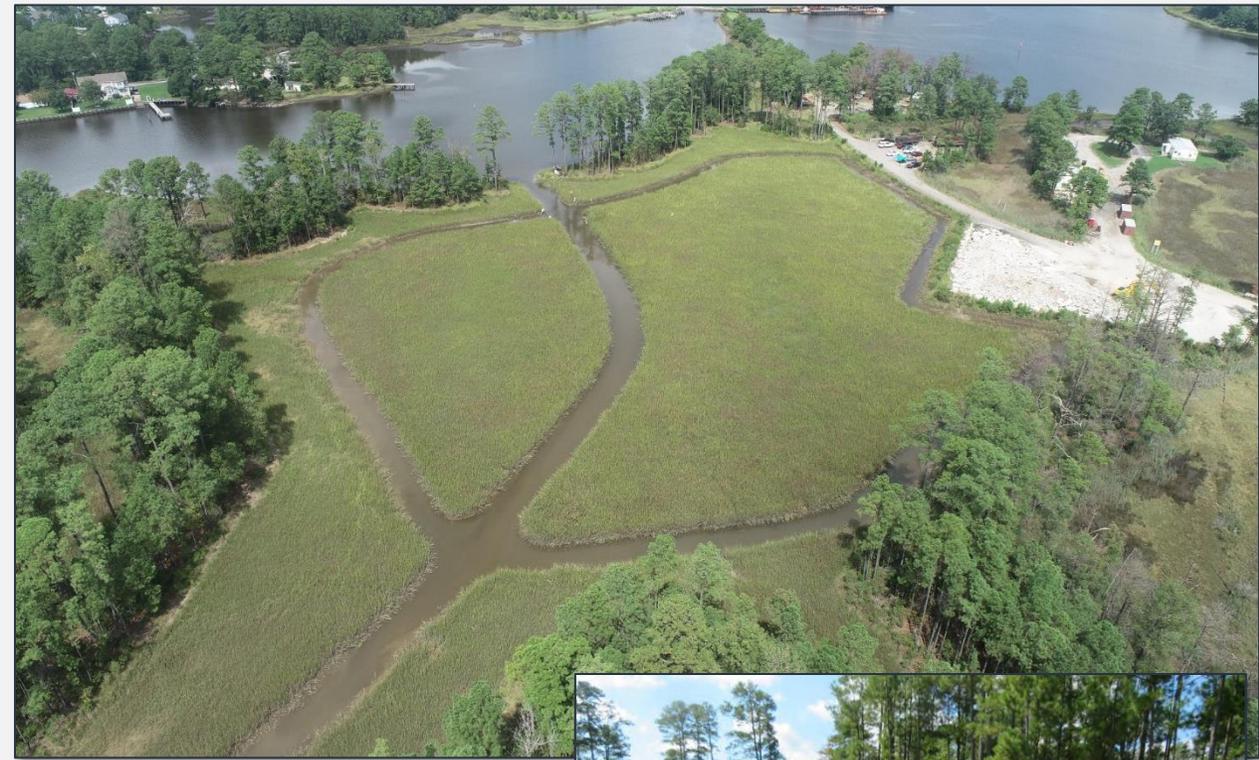
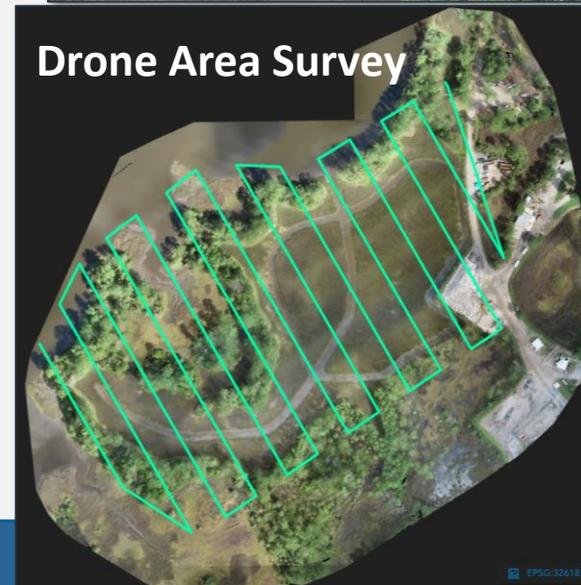
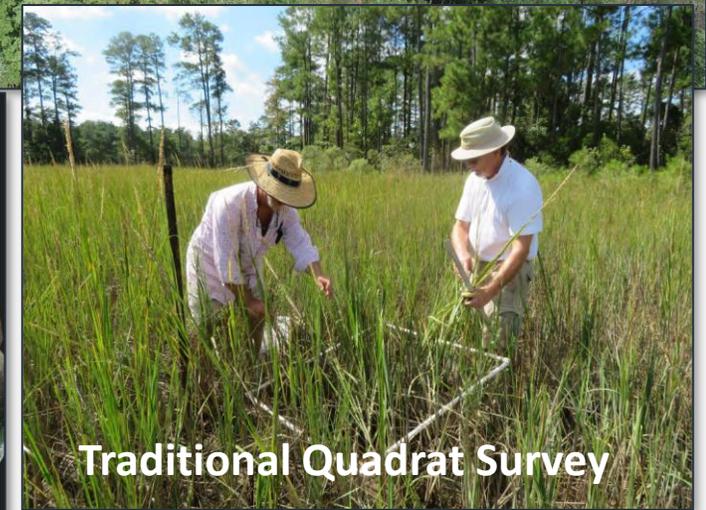
% VEGETATIVE COVER ANALYSIS – NEW MILL CREEK WETLAND MITIGATION BANK

- Comparison of Traditional Quadrat Method vs Drone Method
- Increased Time and Labor Efficiency
- Increased Coverage Area
- Aid in Ground Truthing

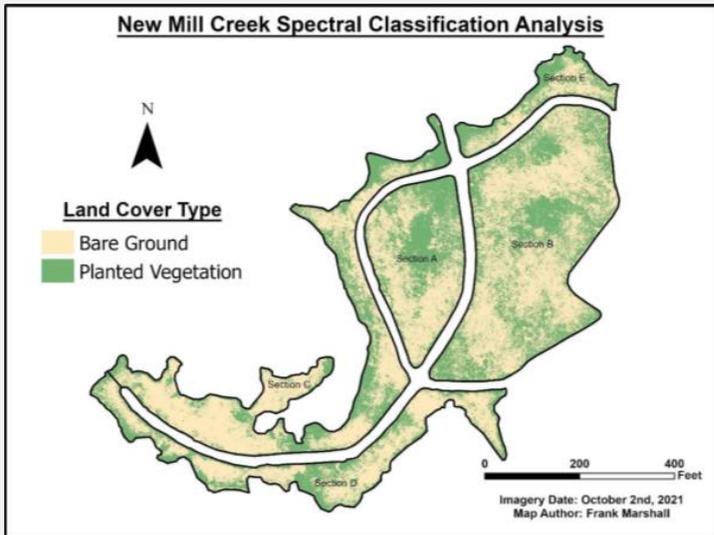
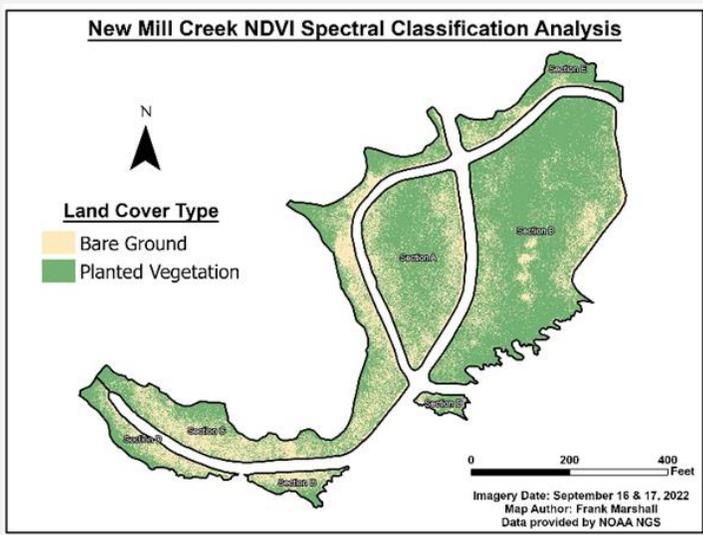
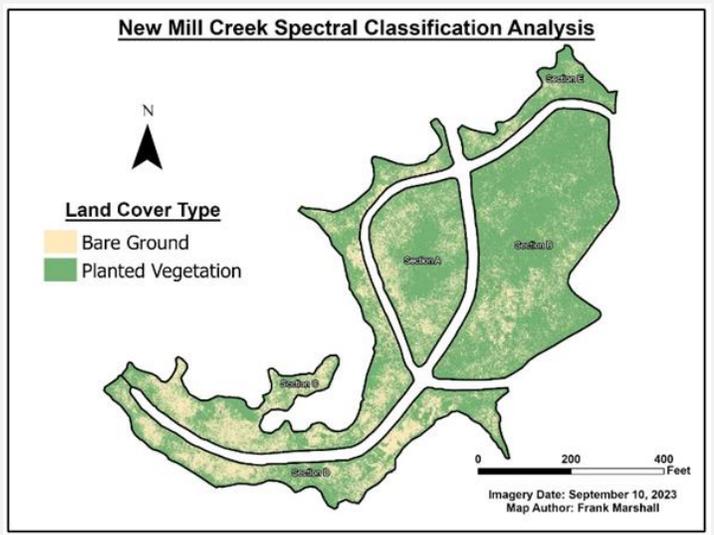
% VEGETATIVE COVER ANALYSIS – NEW MILL CREEK WETLAND MITIGATION BANK

Year	NMC Quadrat	NMC Drone	Pilot Project Quadrat
1	11.17	-	11.84
2	34.45	38.34	44.5
3	42.59	43.27	62.34
4	-	-	69.34
5	61.83	70.84	73.59

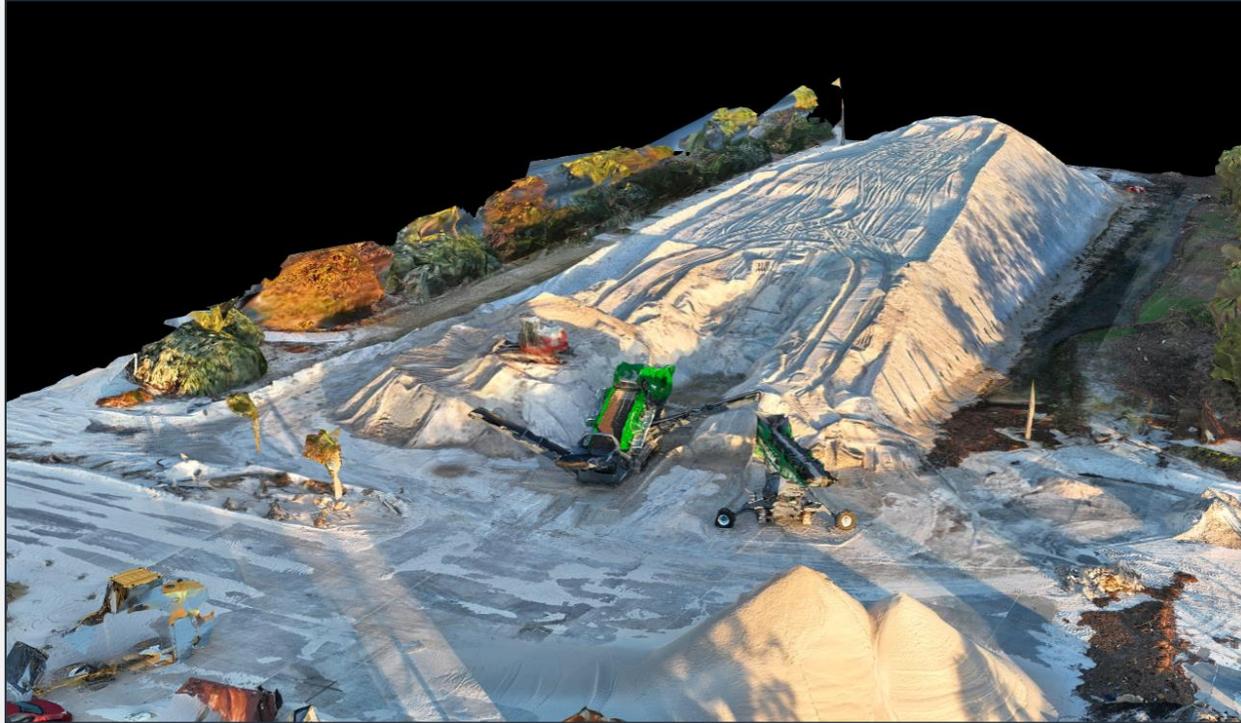
3D Representation of Beach Sand Stockpile

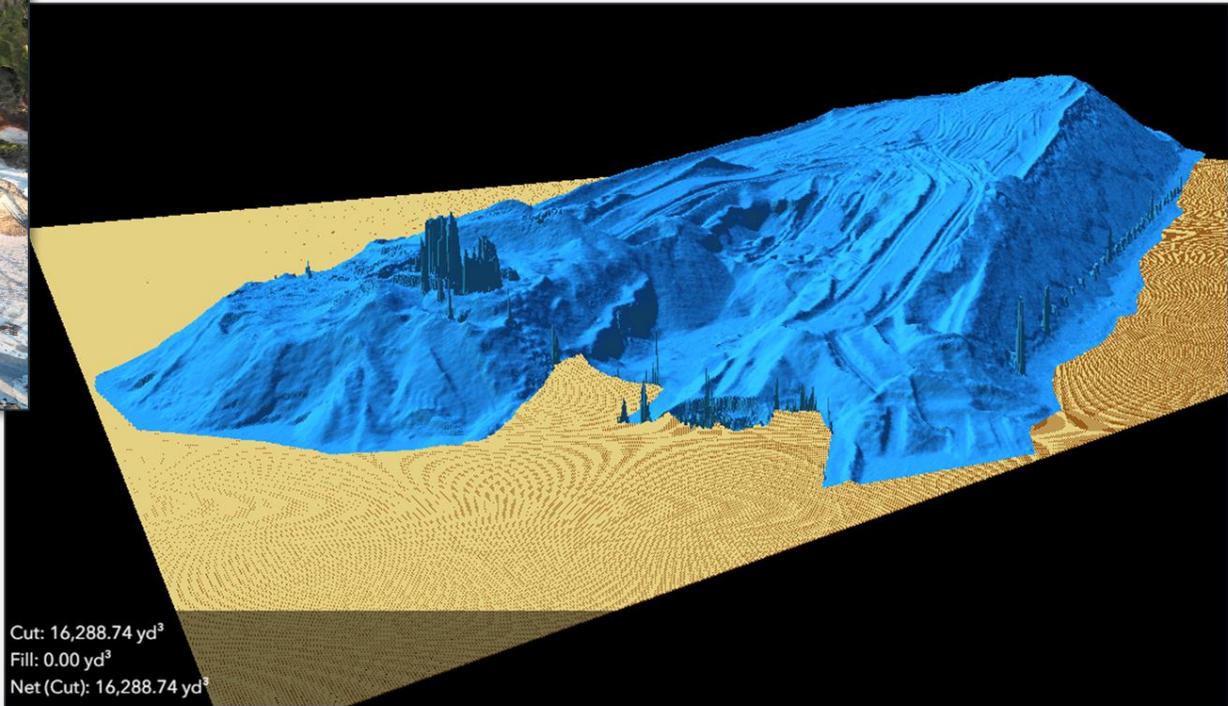
Volumetric Analysis - Surface Comparison
